Re: Assessment & Initial Mitigation Plan for the Exceptional Lahaina Banyan Tree

The following report addresses the Exceptional Banyan Tree in Lahaina, Maui. The State of Hawaii Governor's Office and the Mayor of Maui County requested an assessment and mitigation plan regarding the Indian Banyan tree (*Ficus benghalensis*), which was significantly impacted by the catastrophic fires on August 8-9, 2023.

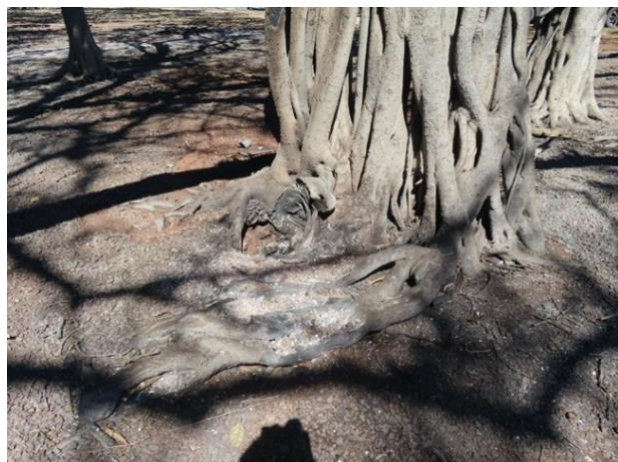
There were no significant signs of singeing, charring or cracking on most of the 40+ aerial roots or main trunk (image, right). Two aerial root trunks appeared to have small sections that had been burned by embers from the fire. I tested the cambium layer around each aerial root to identify if live tissue was present. I used a small pocket knife to cut through the thin bark layer into the cambium layer. All test sites revealed live tissue, with minimal amounts of sap that oozed out of the cut.

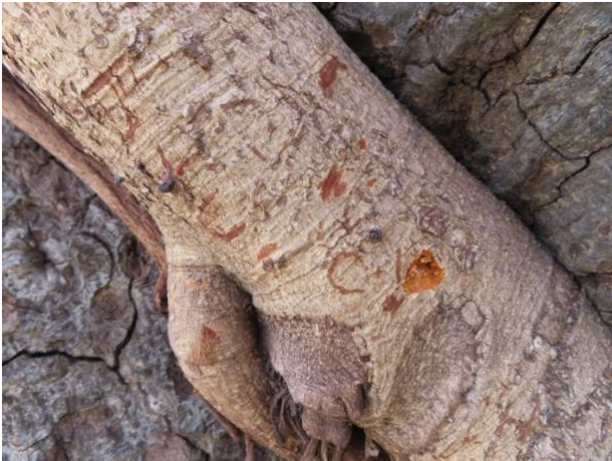
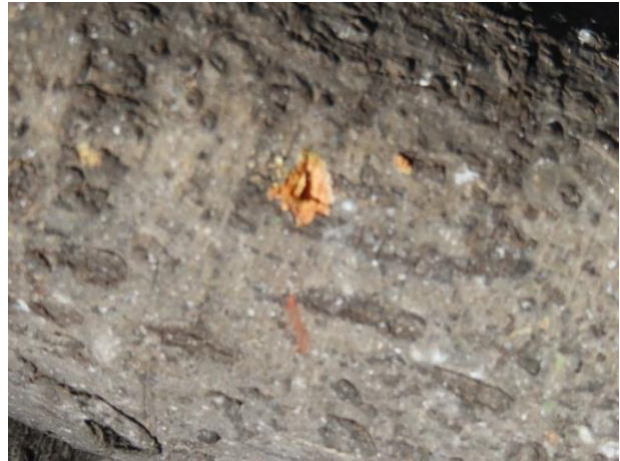
Test cuts into anchored aerial roots show live tissue with minimal sap oozing

The section of the tree towards Front St. and Pioneer Hotel appears to have been the most heavily impacted area of the tree, as this section had the least amount of live cambium tissue in the crown. The rest of the tree did have live tissue in the crown. On a normal and healthy Indian banyan, sap will ooze out excessively when the tree's thin layer of bark is cut. While live tissue and some sap was observed when cutting into the cambium layer in this tree, the amount of sap that oozed was much less than I expected.

- If too much sun is impacting the main branches, wrap the lateral and structural branches in shade cloth
 - Monitor tree health every 2 weeks by testing trunk and aerial root tissue for changes in tissue quality and amount of sap oozing. Record the results. Use results as a gauge for adapting treatments.

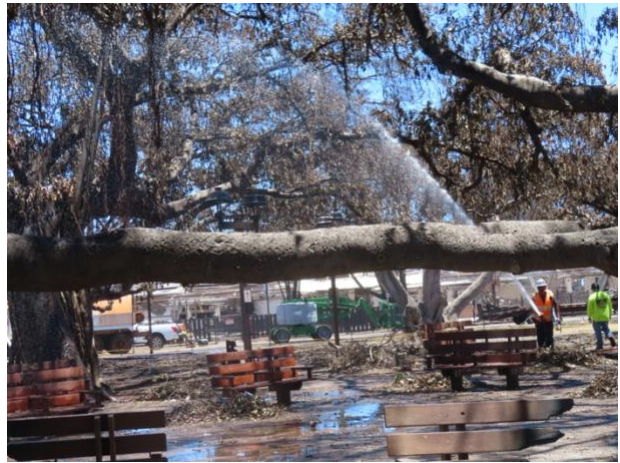
The soil under the tree did not appear to be charred or burned. Goodfellow Bros. watered the soil near the anchored aerial roots. The soil absorbed water quickly with no ponding. The majority of the wooden benches (~90%) beneath the tree were not burned and still intact (pictured, right).

The aerial roots and trunks were the least impacted parts of the tree, and the soil appeared to be normal with minimal evidence of charring or burning. Furthermore, the wooden benches beneath the tree were mostly intact. These observations suggest that minimal fuel beneath the tree's canopy contributed to a lower intensity and less-prolonged burn close to ground level.

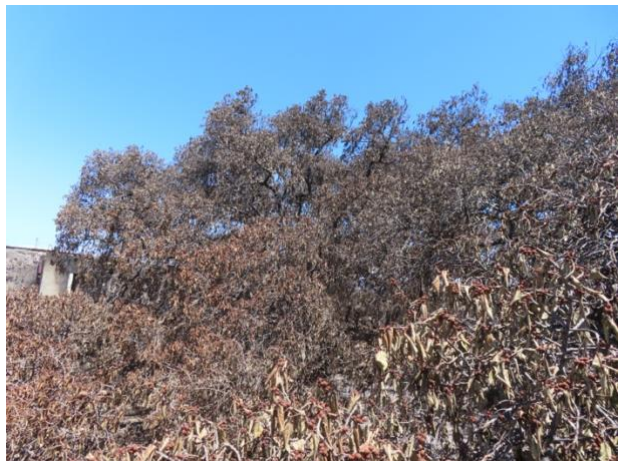
I used the aerial lift to inspect the tree crown around the perimeter and the central upper branches. Leaves and fruits were still attached to the tree, though they were shriveled and brown. The small ¼ in. to 1 in. twigs holding the leaves and fruit were shriveled, desiccated and dead. The 3in. to 8 in. diameter branches attached to the twigs were tested by cutting the outer layer. Many of the branches had live tissue but minimal sap flow. The branches on the corner of Front Street and Pioneer Hotel were dry with some cracks and no signs of live cambium tissue.

- Trunk & Canopy:
 - Presently, leave the dead leaves, twigs and branches on the tree to help protect the inner branches from sun scalding and desiccating during the next two hottest months of the year.

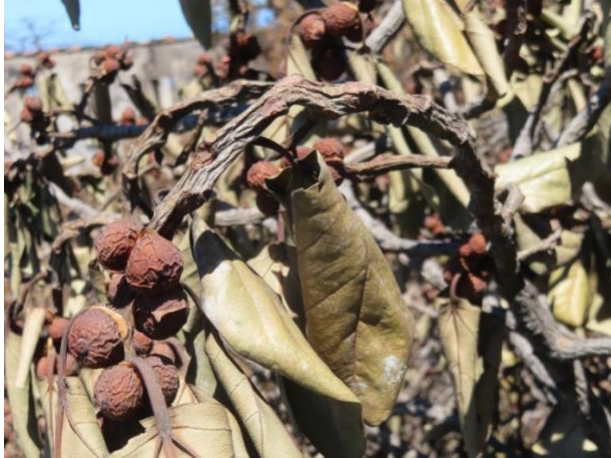
Desiccated leaves and fruit with shriveled twigs

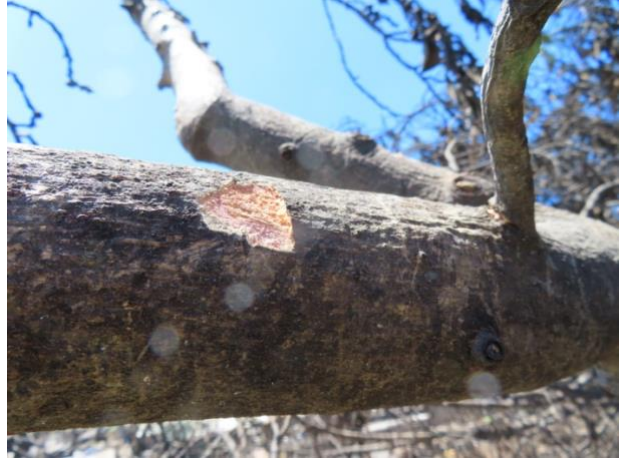
Live cambium in branches

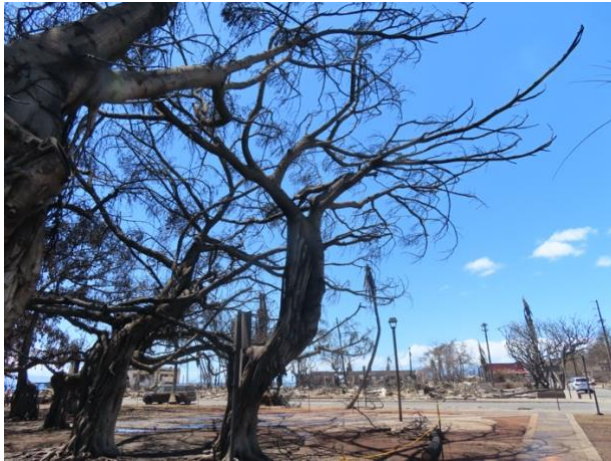
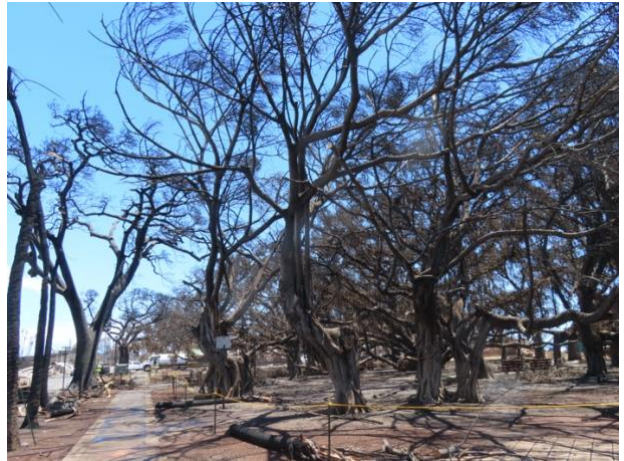
Most heavily burned side of the tree, Front St. and Pioneer Hotel, without live tissue.

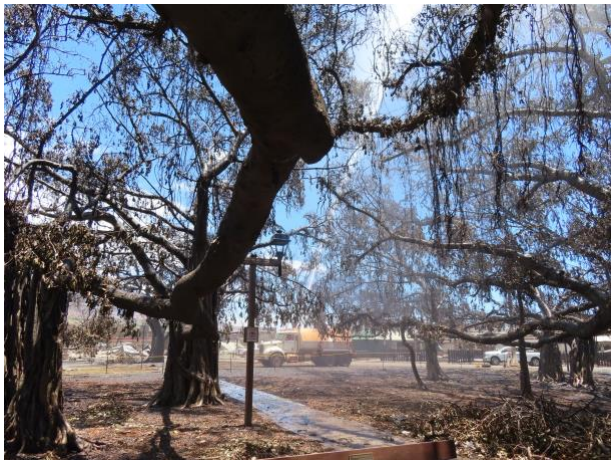
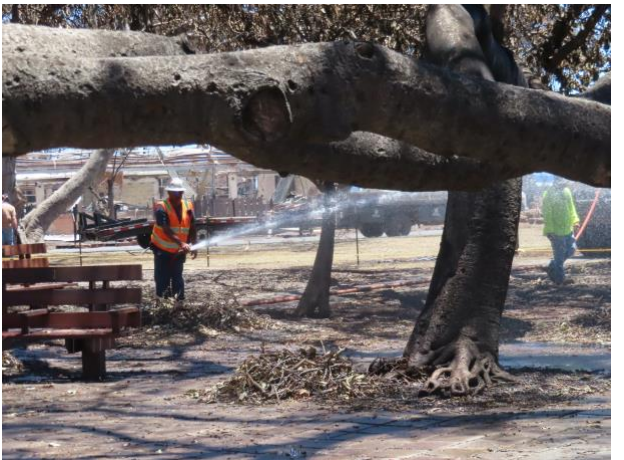
During the inspection, Goodfellow Bros. watered the tree crown to remove the soot and moisten the branches.

- Water:
 - Test water quality (hazardous chemicals, pH, minerals) and apply cleanest water available.
 - Daily watering program of the tree crown and ground, in partnership with Goodfellow Bros. using water trucks with hoses and cannons. Up to 6 trucks of water daily.
 - Monitor soil moisture daily by using soil moisture testing equipment and recording results. Adjust water truck quantities based on results.
 - When the water system is back online and safe to use, replace water trucks by:
 - Repairing and likely replace existing irrigation system.
 - Installing a watering system in the tree's upper crown. Use PVC pipe attached to branches with zip ties to secure sprinkler heads in the upper crown. Water the branches daily on a battery-operated timer system.
 - Watering system can be temporarily connected to a fire hydrant (if functioning and the water is safe to use).
